New Hampshire Volunteer Lake Assessment Program

2003 Interim Report for Hermit Lake Sanbornton

NHDES
Water Division
Watershed Management Bureau
29 Hazen Drive
Concord, NH 03301

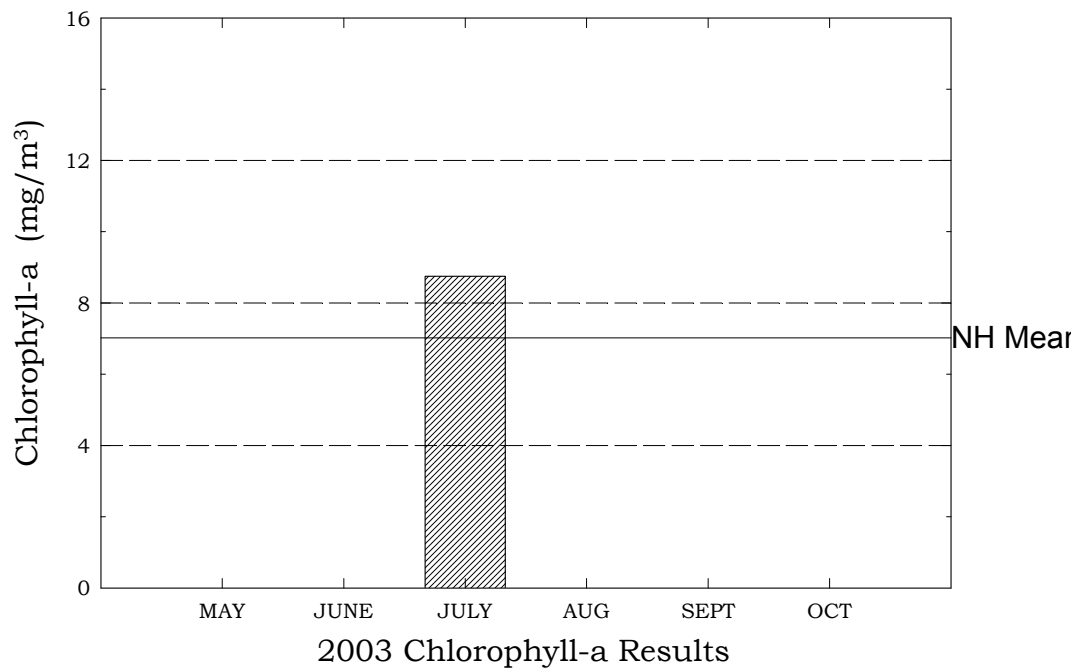
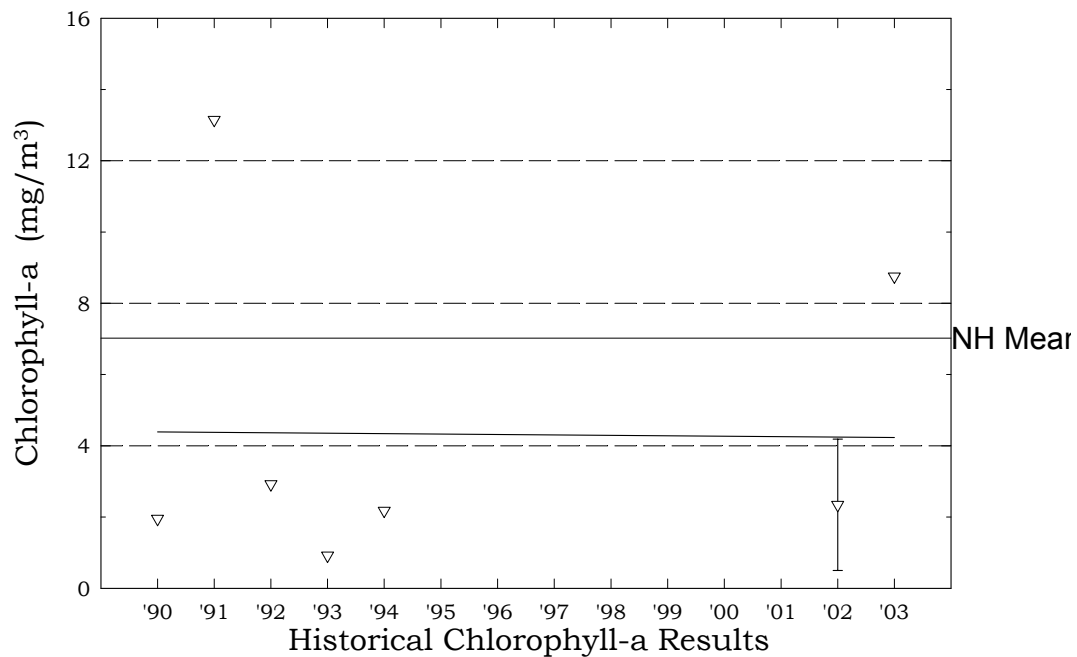
Figure 1. Monthly and Historical Chlorophyll-a Results

- **Figure 1 and Table 1:** The graphs in Figure 1 (Appendix A) show the historical and current year chlorophyll-a concentration in the water column. Table 1 (Appendix B) lists the maximum, minimum, and mean concentration for each sampling season that the lake/pond has been monitored through the program.

The current year data (the top graph) show that the chlorophyll-a concentration in July was ***slightly greater than*** the state mean.

Overall, visual inspection of the historical data trend line (the bottom graph) shows ***a variable*** in-lake chlorophyll-a trend, meaning that the concentration has ***fluctuated*** since monitoring originally began in 1990. (Please note that the pond was not sampled in 1995 – 2001.) After 10 consecutive years of sample collection, we will be able to conduct a statistical analysis of the historical data to objectively determine if there has been a significant change in the annual mean chlorophyll-a concentration since monitoring began.

While algae are naturally present in all lakes/ponds, an excessive or increasing amount of any type is not welcomed. In freshwater lakes/ponds, phosphorus is the nutrient that algae depend upon for growth. Algal concentrations may increase with an increase in nonpoint sources of phosphorus loading from the watershed, or in-lake sources of phosphorus loading (such as phosphorus releases from the sediments). Therefore, it is extremely important for volunteer monitors to continually educate residents about how activities within the watershed can affect phosphorus loading and lake/pond quality.

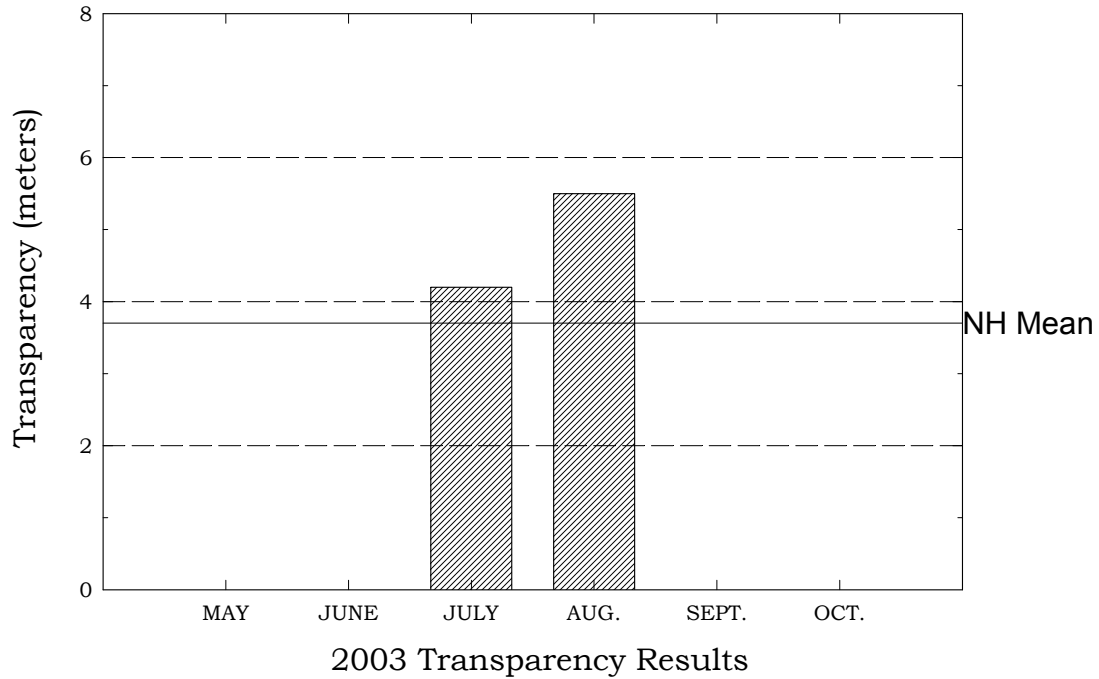
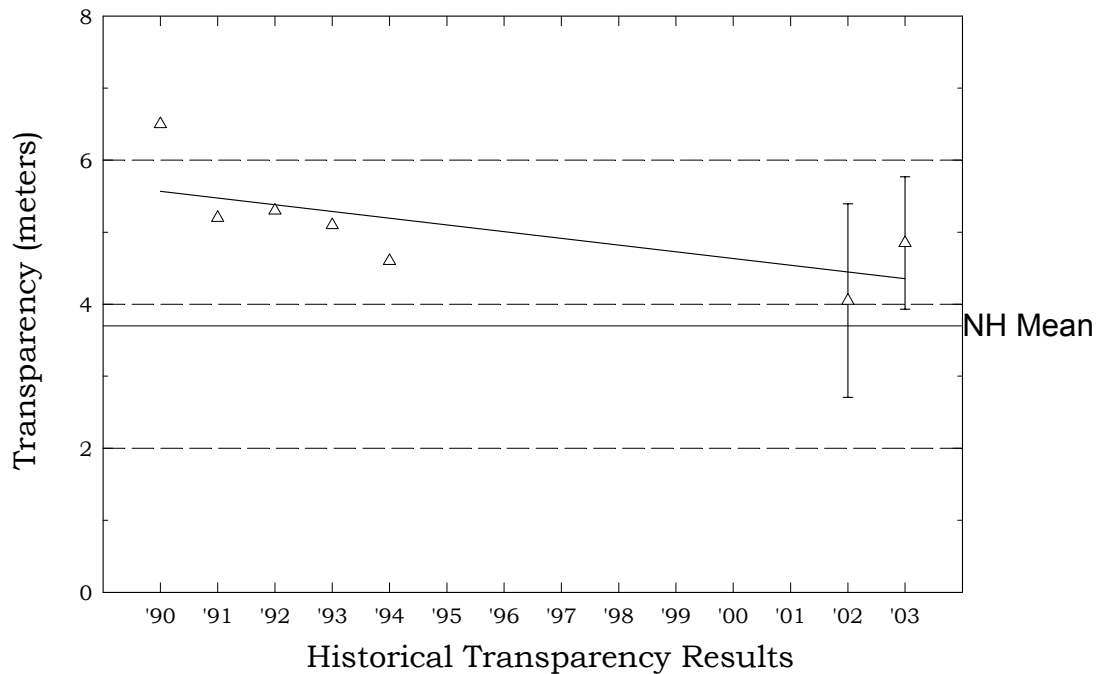
Figure 2. Monthly and Historical Transparency Results

- **Figure 2 and Table 3:** The graphs in Figure 2 (Appendix A) show historical and current year data for lake/pond transparency. Table 3 (Appendix B) lists the maximum, minimum and mean transparency data for each sampling season that the lake/pond has been monitored through the program.

The current year data (the top graph) show that the in-lake transparency **increased** from July to August. The transparency on both sampling events was **greater than** the state mean.

Overall, visual inspection of the historical data trend line (the bottom graph) shows **a slightly decreasing (meaning slightly worsening)** trend for in-lake transparency since monitoring originally began in 1990. (Please remember that the lake was not sampled in 1995-2001). As discussed previously, after 10 consecutive years of sample collection, we will be able to conduct a statistical analysis of the historical data to objectively determine if there has been a significant change in the annual mean transparency since monitoring began.

Typically, high intensity rainfall causes erosion of sediments into lakes/ponds and streams, thus decreasing clarity. Efforts should continually be made to stabilize stream banks, lake/pond shorelines, disturbed soils within the watershed, and especially dirt roads located immediately adjacent to the edge of tributaries and the lake/pond. Guides to Best Management Practices designed to reduce, and possibly even eliminate, nonpoint source pollutants, such as sediment loading, are available from DES upon request. Increase in chlorophyll-a can also lead to decrease in lake clarity.

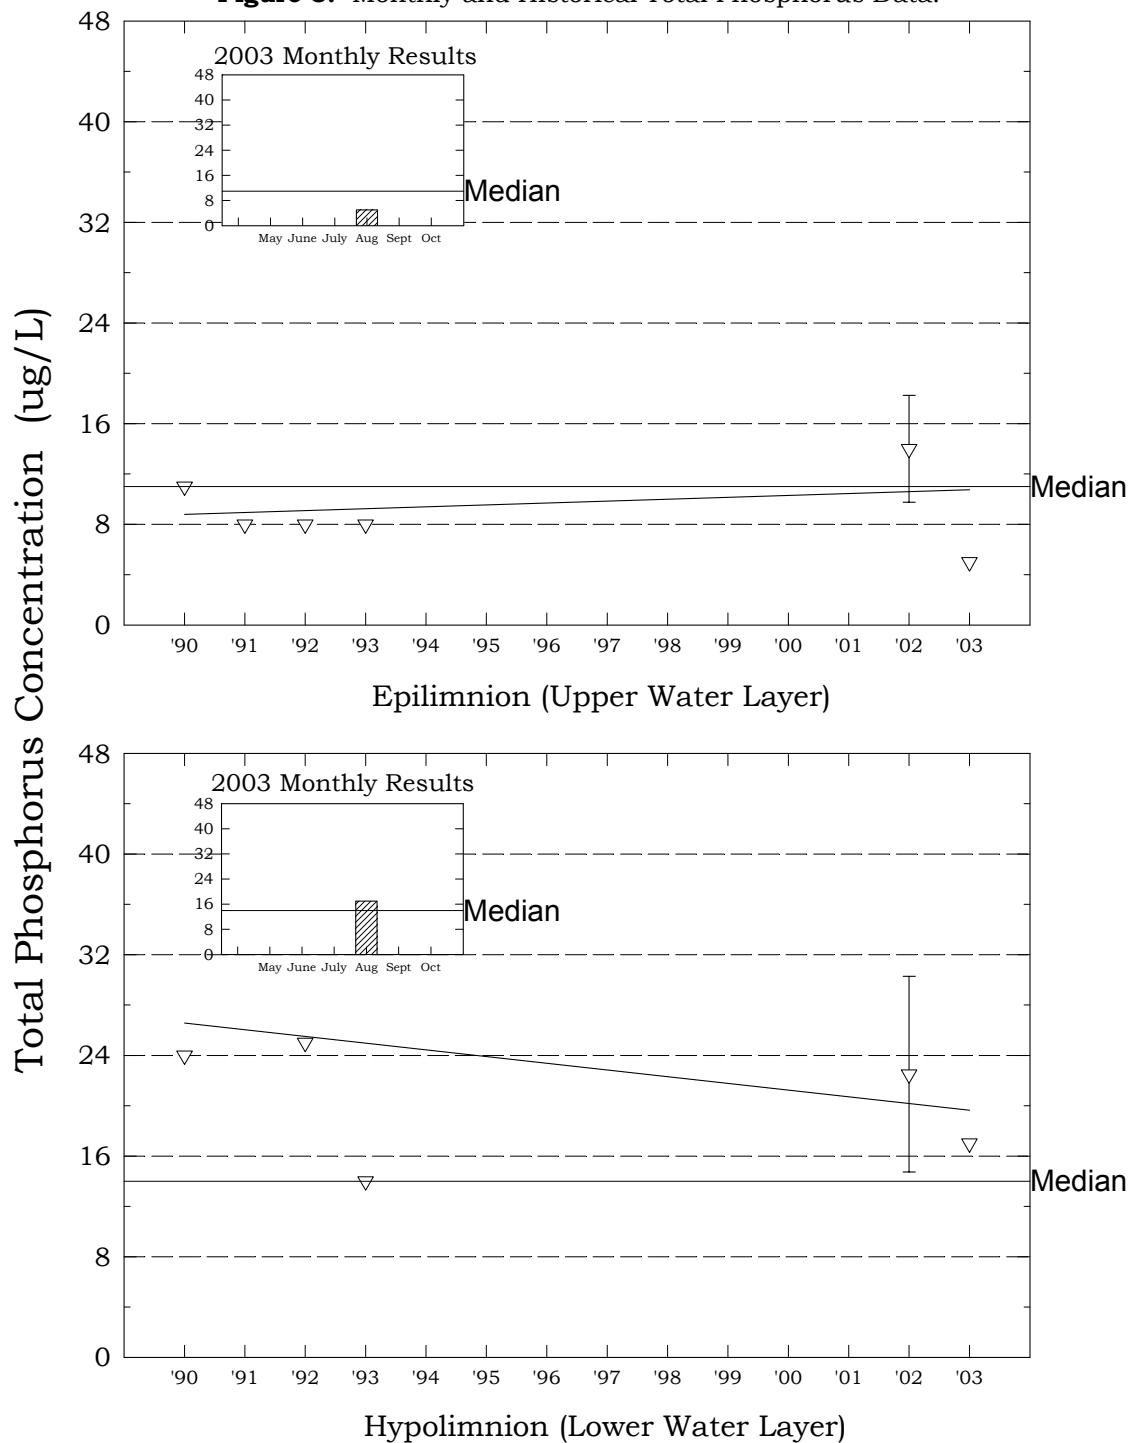
Figure 3. Monthly and Historical Total Phosphorus Data.

- **Figure 3 and Table 8:** The graphs in Figure 3 (Appendix A) show the amounts of phosphorus in the epilimnion (the upper layer) and the hypolimnion (the lower layer); the inset graphs show current year data. Table 8 (Appendix B) lists the annual maximum, minimum, and median concentration for each deep spot layer and each tributary since the lake/pond has joined the program.

The current year data for the epilimnion (the top inset graph) show that the phosphorus concentration in August was ***much less than*** the state median.

The current year data for the hypolimnion (the bottom inset graph) show that the phosphorus concentration in August was ***slightly greater than*** the state median.

Overall, visual inspection of the historical data trend line for the epilimnion and the hypolimnion shows a ***variable*** phosphorus trend, which means that the concentration has ***fluctuated*** since monitoring originally began.

One of the most important approaches to reducing phosphorus loading to a waterbody is to continually educate watershed residents about its sources and how excessive amounts can adversely impact the ecology and value of lakes and ponds. Phosphorus sources within a lake or pond's watershed typically include septic systems, animal waste, lawn fertilizer, road and construction erosion, and natural wetlands.
